Reinforcement of a horizontal tank shell

Pardubice, Czechia

2024

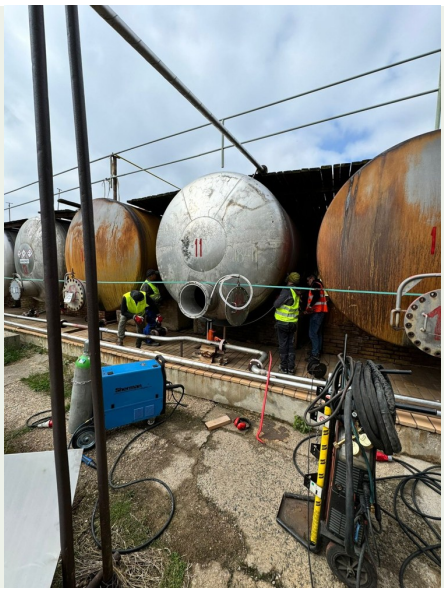
Repair of a horizontal tank shell measuring 12 × 2.7 m in Pardubice. The solution addressed deformed areas near the concrete supports and installation of formed reinforcing plates while retaining the surrounding structures.

- Tank shell repair at the concrete support locations
- Manufacturing drawing for four formed 6 mm reinforcing plates
- Vessel lifting with jacks as specified in the installation proposal
- Reinforcement installation, welding and inspection
